BUILDING FOR ENERGY EFFICIENCY

Thermal imaging of post frame and other construction methods

This article is based upon a May 2010 report prepared for the National Frame Building Association by Double G Consulting (the complete report may be found at nfba.org/technicalarticles). The purpose of this study was to illustrate points of heat transfer in different building types using thermographic images. Builders and design professionals familiar with post-frame buildings know these buildings use fewer structural components to create an exceptionally economical, energy-efficient and environmentally friendly building because fewer structural members are needed, which creates wide spaces between posts with fewer breaks in insulation, and that wood has natural insulating properties compared to steel or masonry structural components. Post-frame construction is therefore believed to reduce some of the heat transfer observed in other construction methods because of wider insulation cavities and less thermal bridging. To illustrate these concepts, thermal images that provide visual examples of heat transfer were captured. The images highlight inefficiencies that may be caused by thermal brid

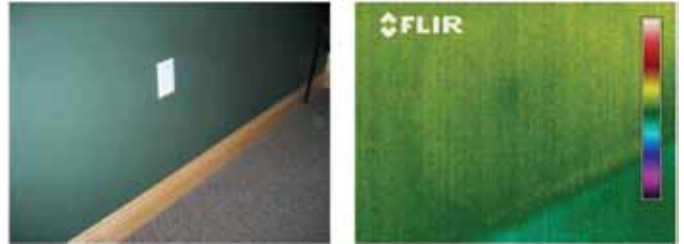
Figures 3, 4, and 5 are images taken inside the post-frame building. Figures 3 and 4 are typical exterior wall images. The temperature of the receptacle in **Figure 3** is very near that of the surrounding area, which indicates that the receptacle is not associated with a change in temperature due to air infiltration and/or a reduced thermal resistance. Similarly, the thermogram in **Figure 4** shows uniform temperatures along the wall surface.

Figure 3. Thermogram indicates no abnormal heat transfer at the receptacle.

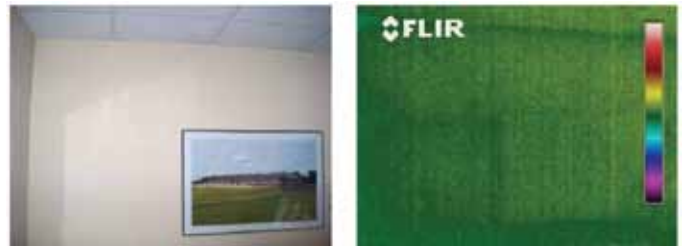
Figure 4. Typical exterior wall. Thermogram indicates no abnormal heat transfer.

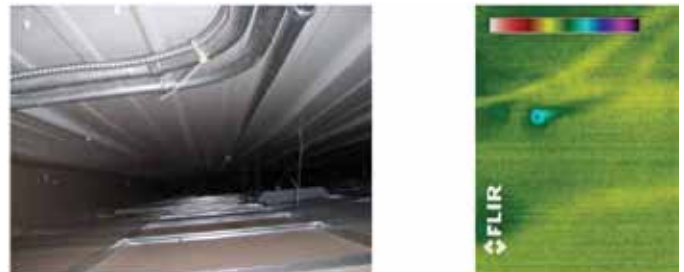
Figure 5 shows a region above the suspended ceiling. Although there are no signs of air infiltration or exfiltration at seams between corrugated steel panels, a spot on the electric conduit does register a colder temperature than the surroundings. Thermal bridging may be caused by a steel electrical box, bracket or screw.

Figure 5. Cavity above suspended ceiling. Although no signs of air infiltration or exfiltration at panel seams appear, a spot on the electric conduit does register a colder temperature than that of the surroundings.

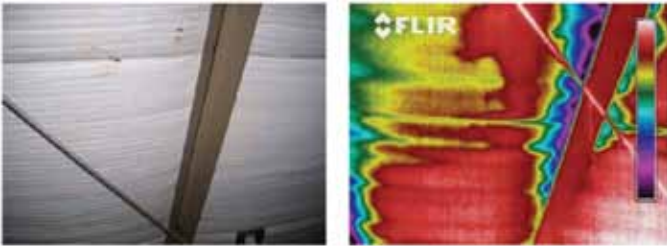
As shown in **Figures 7–10**, significant variations in thermal envelope heat transfer likely due to heat transfer were observed in this building, particularly at eave struts, roof purlins and columns. These variations were due primarily to compression of the fiberglass insulation at these framing members. When viewing the thermograms in **Figures 7, 8 and 9**, note the varia-

Figure 7. Thermogram of a single roof purlin shows increasing drop in surface temperature as thickness of insulation decreases near purlin.

tion in the temperature across each steel framing member. Inside flanges have temperatures closer to the building's interior temperature, while the flanges in contact with the compressed insulation have measurably lower temperatures.

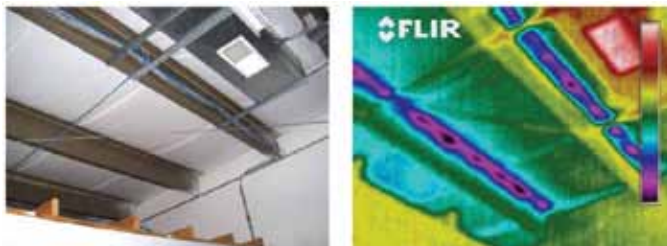
Figure 8. Thermogram shows similar temperature profiles for adjacent purlins.

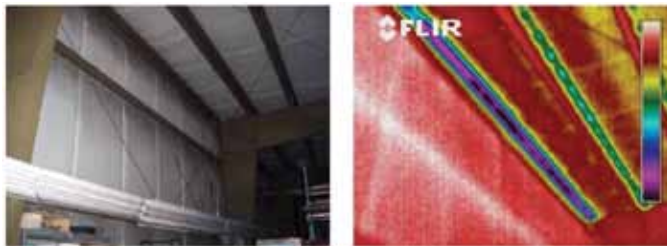
Figure 9. Image shows lowest temperatures occurring where insulation is compressed by eave strut. Exterior corners in all buildings are generally associated with greater heat loss per unit area.

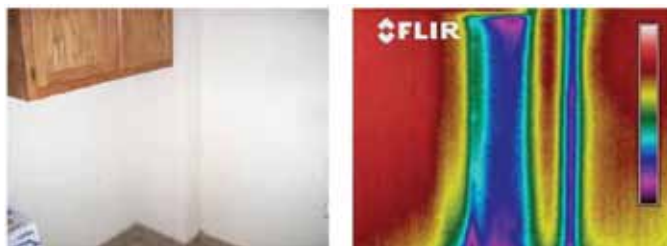
Figure 10. Covering around each steel column showed a similar temperature profile, a pattern indicating elevated heat transfer at column locations.

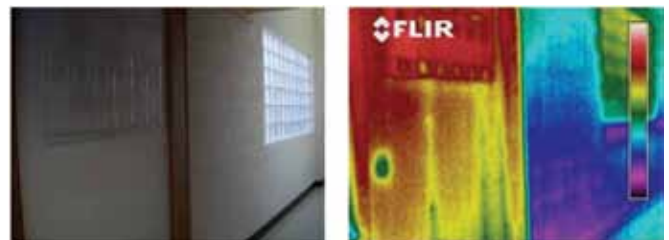
Figure 12. Images of the transition between the insulated and non-insulated concrete block walls in the masonry building.

The thermogram in **Figure 12** is as definitive as you will find in thermal imaging. In this case, it shows the difference a small amount of wall insulation can make, as well as elevated heat transfer near an uninsulated foundation. The thermogram in **Figure 12** also shows the interior surface of the glass block and mortar between the glass block to be at a higher temperature than the surrounding concrete block. This is most likely due to transmittance of solar radiation through the glass block.

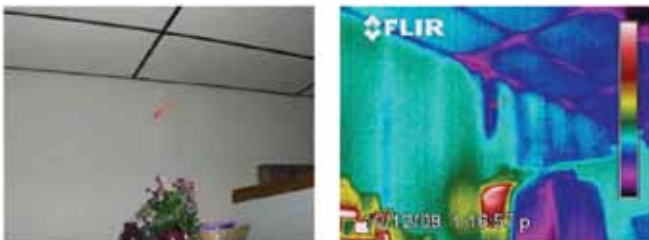
Figure 14. Air infiltration into a wall cavity during blower door testing.

The wood stud-framed building was relatively leaky, with a measured infiltration of 10,300 cubic feet per minute at 50 pascals of differential pressure. Blower door testing revealed measurable air infiltration at bottom and top plates, as well as air exchange between wall cavities and the adjacent attic zone as a result of electrical and other penetrations through the framing (see **Figure 14**). These penetrations can be resolved with appropriate measures.

The most significant air leakage in the wood-stud building was at the ceiling, as evidenced by the lower temperatures

around the suspended ceiling grid in **Figure 14**.

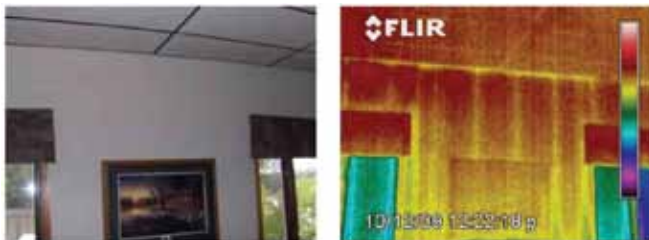
Figure 15. Thermogram shows lower surface temperatures in areas backed by wood studs.

As shown in **Figure 15**, the stud-wall building showed reduced thermal resistance at wall studs, indicated by the streaking color in the wall. Depending on the size of framing used for a wall (2x4, 2x6, etc.) and the spacing of the studs, the heat loss through framing can vary from 33 percent to 49 percent of the total (Seifert, n.d.).
