BETTER FALL PREVENTION

Testing of fall arrest anchors connected to trusses

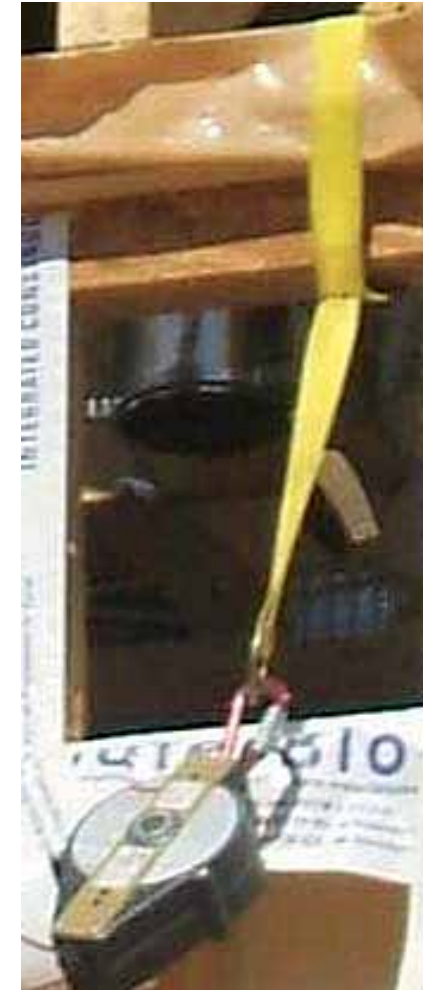
Figure 1 Photo from OSHA 2011 guidance document showing a questionable attachment to a wood member.

The Structural Building Components Association (2011) has produced document B11, "Fall Protection and Trusses," to provide information about fall protection on job sites. This article explicitly shows an image of a worker with a lanyard looped around a truss and a large red 'X' through the picture. However, an OSHA guidance document (2011) titled "Fall Protection in Residential Construction" shows many different methods for compliance with the changes in fall arrest provisions. **Figure 1** is a photograph from the OSHA document that appears to show a lanyard wrapped around a wood member. The photo is cropped, so it is impossible to see what the wood member is (e.g., rafter, truss, brace, nonstructural support).

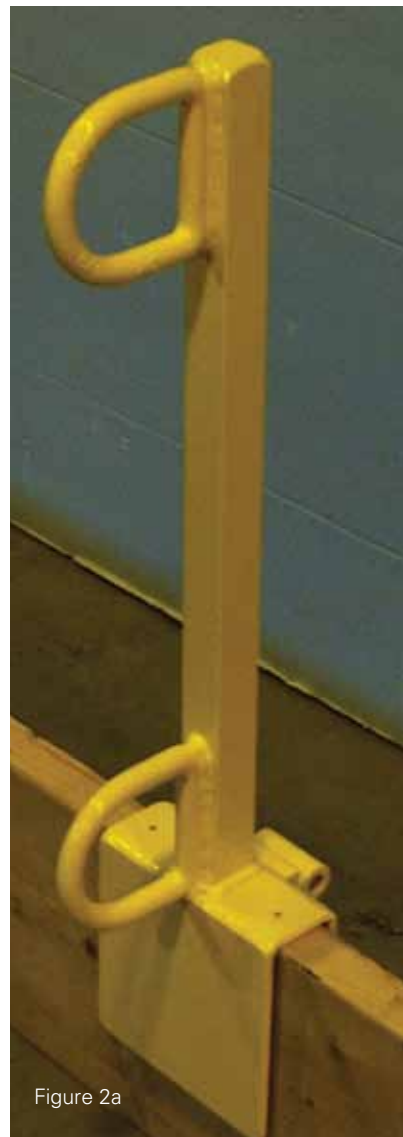
Figure 2a

Figure 2
Post-frame fall arrest system: (a) eave bracket, (b) peak bracket, (c) sheathing bracket

The photographs in Figure 2 show three different anchors used. The first two anchors, (a) and (b), are attached to the eave and peak of the truss, respectively. These anchors can be installed on the first truss before it is lifted into position. The third anchor, (c), is used when sheathing is applied to the trusses.

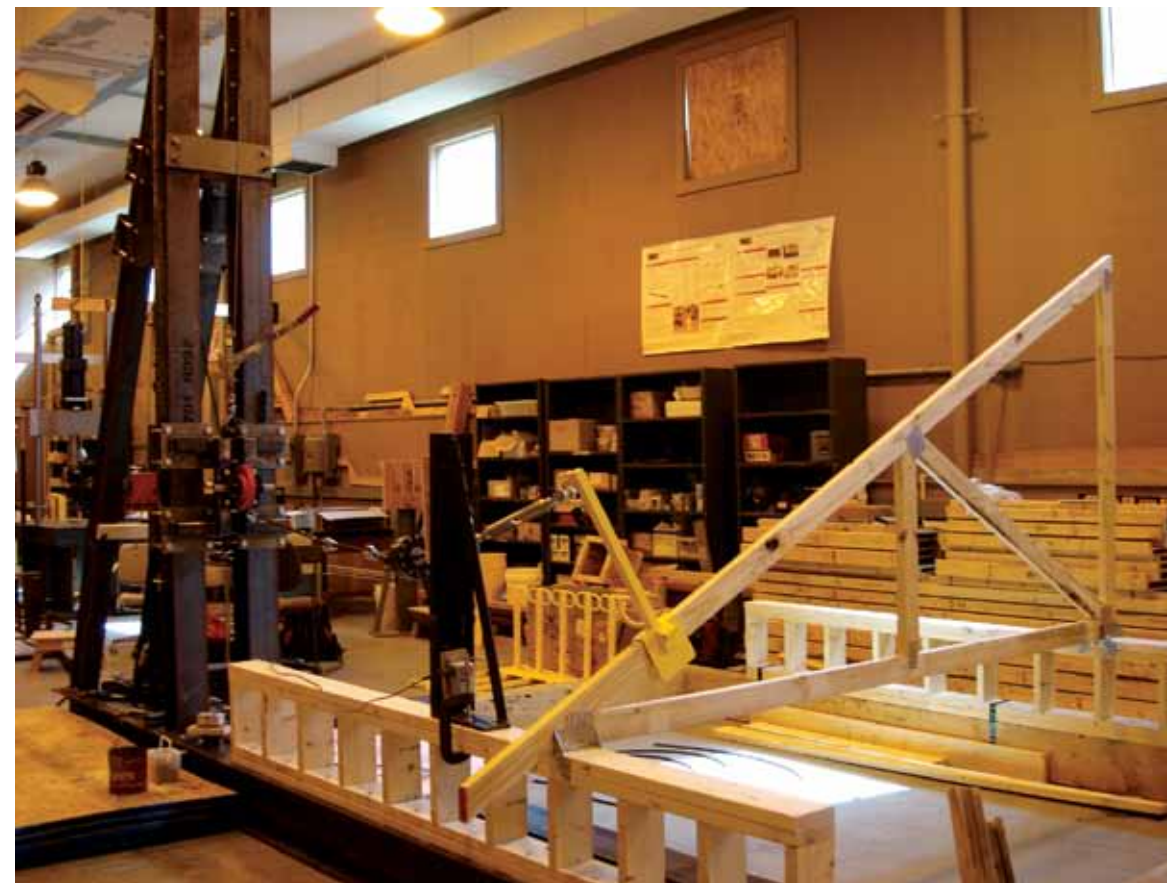
Figure 3
Horizontal application of load test (HALT), with test truss mounted using eave bracket

To test the mechanical strength of both the PFAS and the RFAS, a new test machine labeled the HALT (horizontal application of load test) was constructed (see Figure 3). The HALT uses a hydraulic cylinder placed in a vertical position (it is inside the steel frame at left but not visible in the picture) to pull on a steel cable threaded through a series of pulleys. The pulley closest to the truss can be moved up and down the steel frame so the anchors can be tested horizontally at varying positions along the trusses. The cylinder has a maximum capacity of 7,000 pounds and a maximum distance of travel of 20 inches. The HALT is attached to a set of two 2x6 stem walls placed 10 feet apart. The HALT load point is located approximately 18 inches from one wall end to place the maximum load possible on a single connection, representing a worst-case failure load.

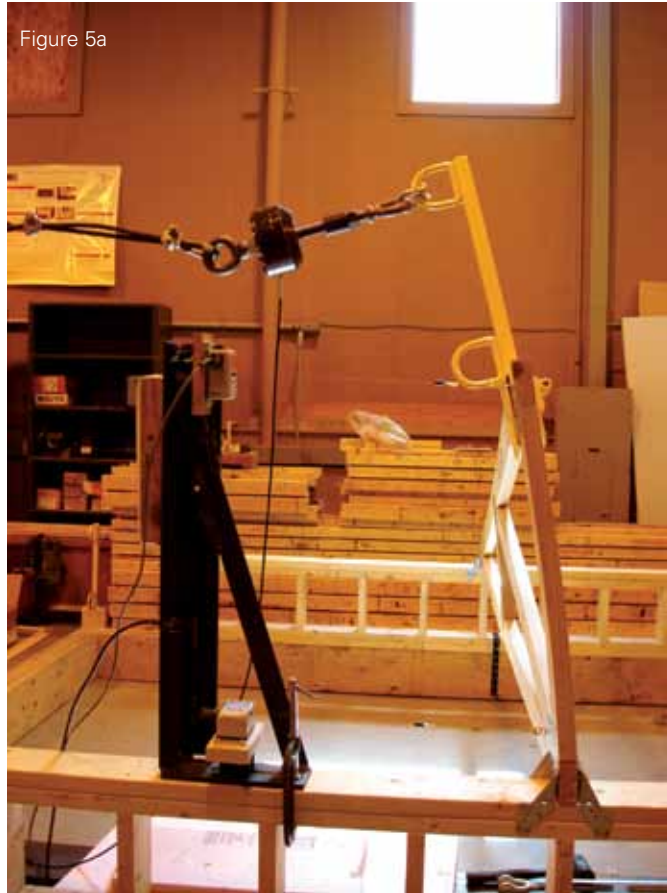
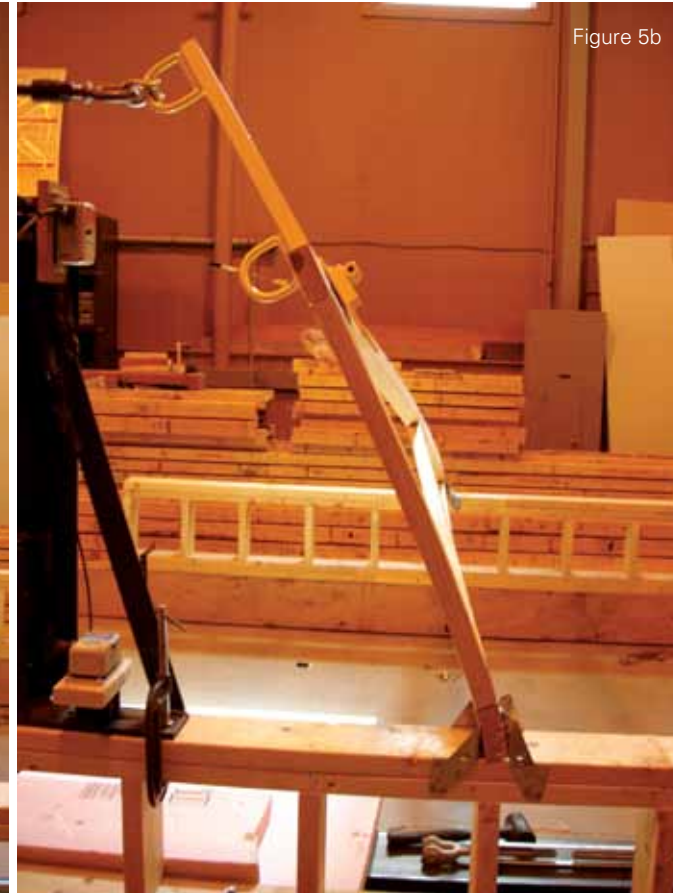
Figure 5
Sequential testing of loading showing anchor attachment to truss (eave bracket)

The photographs in Figure 5 show the loading of a truss at the peak. The large black cylinder is a load cell placed near the bracket.

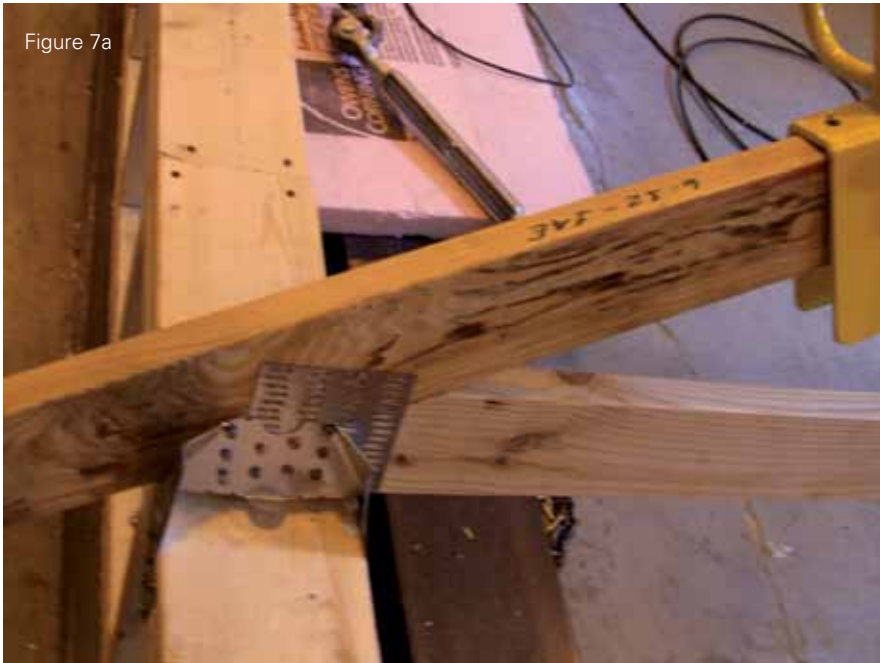
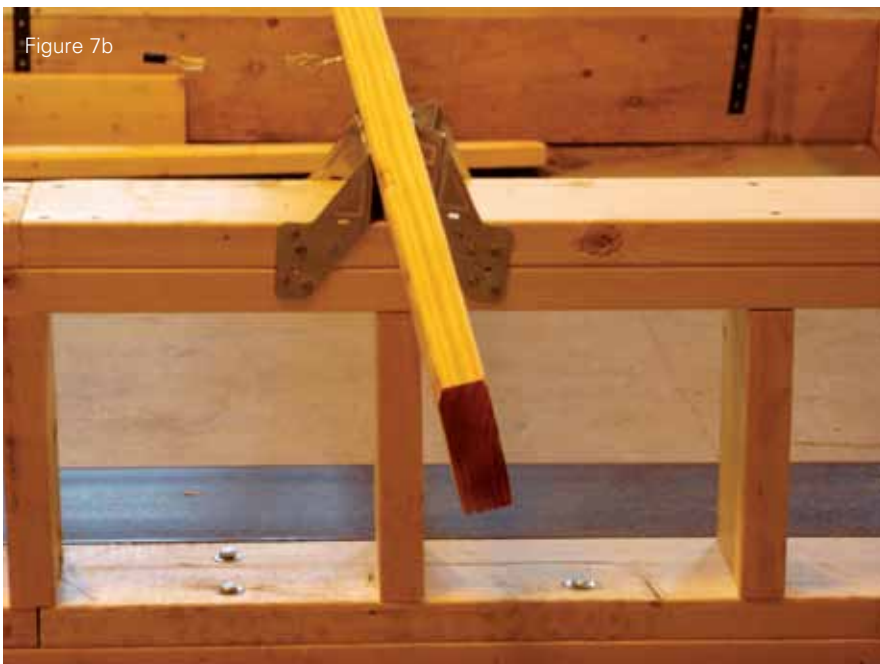
**Figure 7**

Ductile failure of truss-wall connection showing yielding of connector

If the truss bracing enhancer fasteners overlapped the truss plates, the reinforcement of the truss plate prevented brittle failure due to torsion. The failure mode changed to a ductile failure of the truss bracing enhancer itself where the bracket rotated the fasteners in the top plate of the wall. Figure 7 contains two photographs of the ductile failure of the truss-wall connection, showing the rotation of the truss and the lifting of the back side of the truss bracing enhancer off the top plate.
