BUILDING FOR ENERGY EFFICIENCY

Thermal imaging of post frame and other construction methods

This article is based upon a May 2010 report prepared for the National Frame Building Association by Double G Consulting (the complete report may be found at nfba.org/technicalarticles). The purpose of this study was to illustrate points of heat transfer in different building types using thermographic images. Builders and design professionals familiar with post-frame buildings know these buildings use fewer structural components to create an exceptionally economical, energy-efficient and environmentally friendly building because fewer structural members are needed, which creates wide spaces between posts with fewer breaks in insulation, and that wood has natural insulating properties compared to steel or masonry structural components. Post-frame construction is therefore believed to reduce some of the heat transfer observed in other construction methods because of wider insulation cavities and less thermal bridging. To illustrate these concepts, thermal images that provide visual examples of heat transfer were captured. The images highlight inefficiencies that may be caused by thermal brid

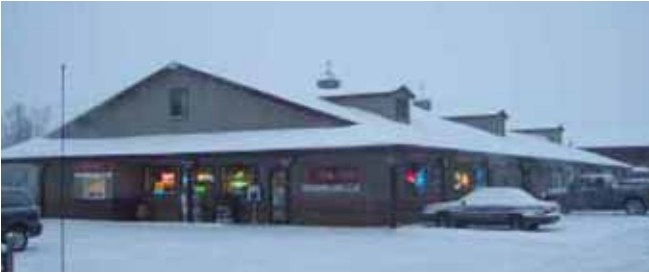
Figure 2. Post-frame building involved in thermal envelope study.

envelope study is shown in **Figure 2**. This structure was a mixed-use facility (office and commercial retail) with R-19 fiberglass insulation in the walls, R-38 cellulose insulation in the ceiling, and R-8.1 polystyrene insulation encasing the perimeter of the foundation.

The post-frame building's blower door test measured 4,700 cubic feet per minute of leakage at 50 pascals of differential pressure. This infiltration appeared to occur at electrical and plumbing penetrations, a problem that can be investigated (and subsequently resolved) with minor measures taken prior to completion of construction. Differential surface temperatures may also indicate higher heat-transfer rates where insulation is interrupted by posts or laminated wood columns and at floor-to-wall junctures, or thermal bridging.

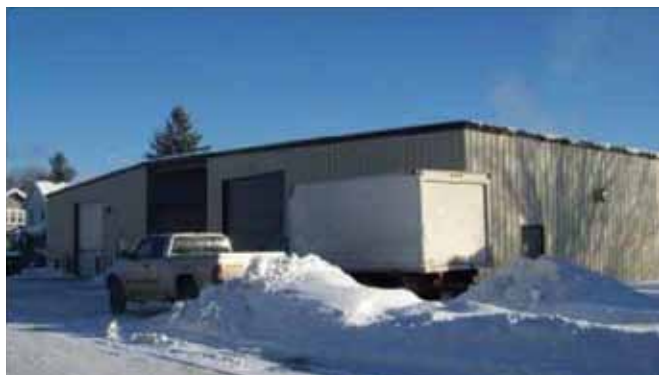
Figure 6. Rear view of low-rise steel-frame building involved in thermal envelope study.

An image of the low-rise steel-frame building investigated as part of the NFBA thermal envelope study is shown in **Figure 6**. This facility housed a news publishing business and featured R-19 fiberglass insulation in the walls and R-19 fiberglass insulation in the ceiling. The perimeter of the foundation was not insulated. This was a massive building combined with major air leakage points; it was not possible to depressurize the building.

As shown in **Figures 7–10**, significant variations in thermal envelope heat transfer likely due to heat transfer were observed in this building, particularly at eave struts, roof purlins and columns. These variations were due primarily to compression of the fiberglass insulation at these framing members. When viewing the thermograms in **Figures 7, 8 and 9**, note the varia-

During the analysis of the steel-frame building, lower surface temperatures were located near base plates, indicating higher heat transfer due to the lack of foundation perimeter insulation in this particular building.

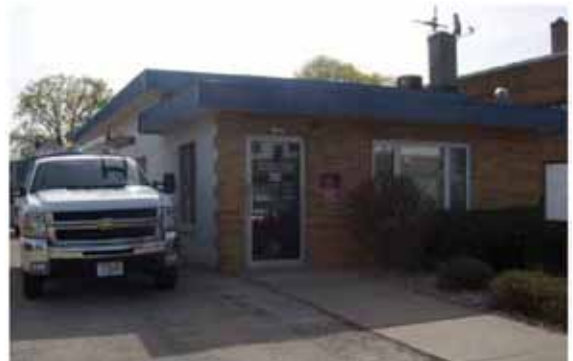
Figure 11. Masonry building involved in thermal envelope study.

An image of the masonry building investigated as part of the NFBA thermal envelope study is shown in **Figure 11**. This structure was a utility facility. The front office portion featured concrete block furred out with 2x2 lumber and insulated with R-5.8 fiberglass batts. The rear portion of the structure was untreated concrete block ($R = \sim 1.0$). Ceilings were insulated with R-19 fiberglass batts. There was no foundation insulation.

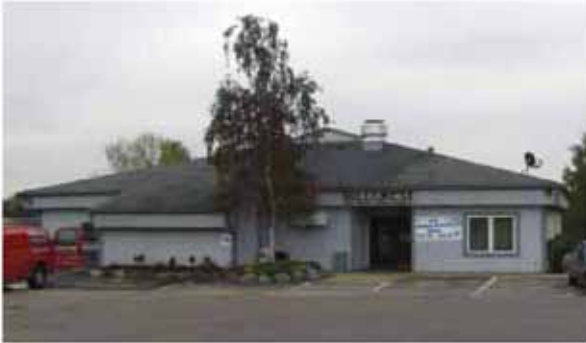
Figure 13. Wood stud-framed building involved in thermal envelope study.

An image of the wood stud-framed building investigated as part of the NFBA thermal envelope study is shown in **Figure 13**. This structure was a restaurant with 4,125 square feet of conditioned space and featured walls with R-11 fiberglass batt insulation and ceilings with R-38 cellulose insulation. The foundation perimeter was not insulated.

The wood stud-framed building was relatively leaky, with a measured infiltration of 10,300 cubic feet per minute at 50 pascals of differential pressure. Blower door testing revealed measurable air infiltration at bottom and top plates, as well as air exchange between wall cavities and the adjacent attic zone as a result of electrical and other penetrations through the framing (see **Figure 14**). These penetrations can be resolved with appropriate measures.
