The Post-Frame Fire Wall: New, Tested, and Economical

Glenview, IL—The National Frame Building Association (NFBA) has successfully achieved a 3-hour fire rating for a postframe wall system that can now be incorporated into a post-frame building without having to go to more expensive nonwood framing systems.

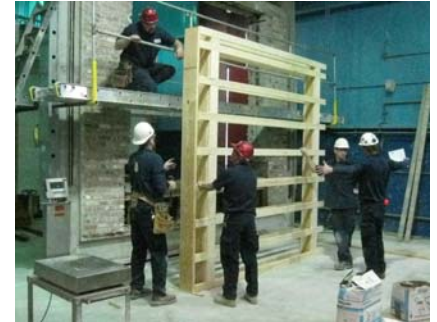
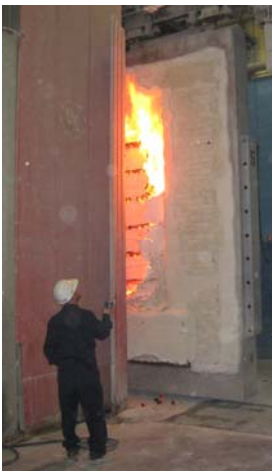
The test wall assembly was a post-frame structure with four layers of 2 x 6 laminations in the columns, spaced 8 feet apart with 2 x 4 girts 16 inches on center applied horizontally on each side. The frame was then sheathed with four staggered layers of 5/8 type X drywall on both sides. All joints were non-taped.

Full-scale testing of a 3-hour post-frame fire wall by Underwriters Laboratories (UL), Northbrook, IL, showed for the first time that a wood-constructed assembly is a viable alternative to a traditional block wall system. UL testing was completed in December 2011.

“The post-frame assembly tested nearly made 4 hours (3 hours and 47 minutes), thus obtaining UL’s 3.5-hour rating,” said Leo F. Shirek, co-chair of NFBA’s Technical and Research Committee and a member of its 3-Hour Post-Frame Fire Wall Subcommittee. “It’s quite a testament to the quality of post-frame construction.”
