# POST-FRAME SUCCESS

## Post-Frame 3-hour fire wall surpasses three-hour test

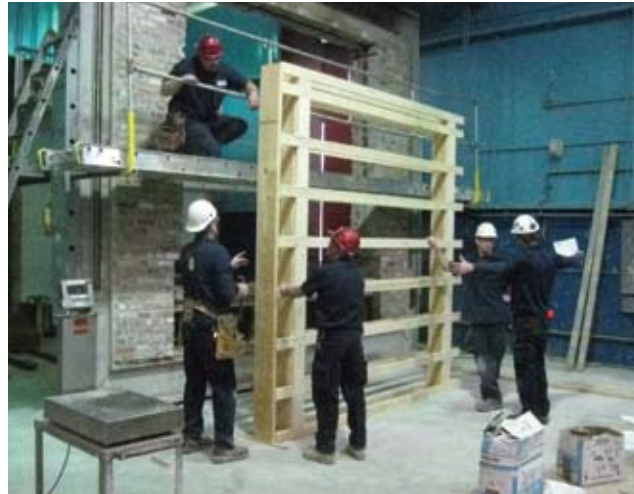
This wood-constructed fire wall is a unique product and quite a testimonial to our industry's achievement. Our subcommittee had numerous ideas that were incorporated into the final design, but we also turned to two industry experts to help us in our investigation to determine the final framing and sheathing design: Kuma Sumathipala, PhD, of the American Wood Council and Robert H. White, PhD, of Forest Products Laboratory, Madison, Wis., where we conducted six small-scale preliminary tests that helped with decision making on the final design.

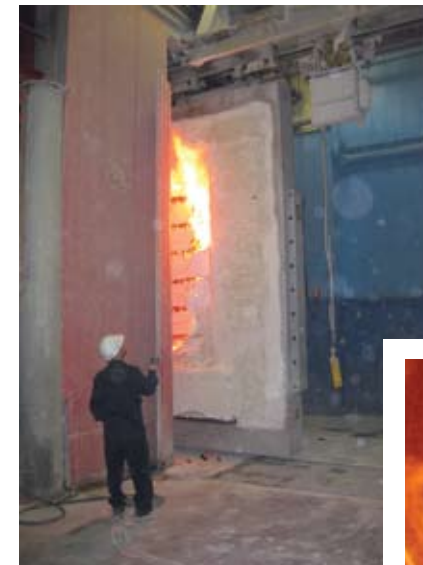
along with testing two grade types, type C and type X. Type C drywall is a little bit more fire-resistant but did not present itself as such in our test, and that is one reason we settled on four layers of type X. Our final assembly then was a post-frame structure with four layers of 2 x 6 laminations in the columns, spaced 8 feet apart with 2 x 4 girts 16 inches on center applied horizontally on each side. This frame was then sheathed with four staggered layers of 5/8 type X drywall on both sides. All joints were untapped.

In the test, our assembly nearly made 4 hours (3 hours and 47 minutes), thus obtaining UL's 3.5-hour rating. The UL testing group nicknamed our assembly "the Fortress" because they normally test stud walls and the like. This test presented a different challenge for them, and you can see by the results that we earned the name. It's quite a testament to the quality of post-frame construction.

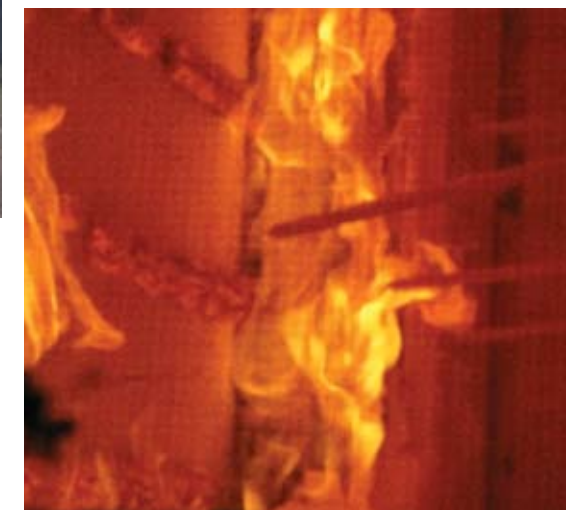
A: The UL-approved assembly came about by confirming the adequacy of a 10 x 10-foot tested sample of what will be built in the field. These tests follow the requirements of the UL 263 (ASTM

E119) standard of ASTM International [formerly known as the American Society for Testing and Materials]. One must follow stringent requirements to pass this test. For this testing we went to UL, in Northbrook, Ill., in December 2011. To pass the test, two duplicate test assemblies were run. In the first fire test, the assembly's test-to-failure duration was 3 hours and 47 minutes. In the second test, the assembly was subjected to a fire test of one hour and then a stringent water-

- When the assembly frame was tested, a load was added to the structure to simulate maximum roof loads that the columns on the building are capable of carrying. Hydraulic pressure rams were used to put a load on the assembly of about 42,000 pounds — a lot of weight.

- A blast of fire comes out of 20 holes during testing to bring the furnace to about 1,800 degrees F. Thermocouples within the furnace and at various locations on the assembly sense the temperature, which is sent to and recorded on computers in a nearby control room. This log of data helps in any later engineering study for other possible approvals based on this test.

- An hour into the test, the exposed gypsum drywall loses its moisture and starts to shrink up. Joints start to open up. At 2 hours, two layers of drywall had fallen off, and a half-hour later a flame began exposing the fourth layer. At nearly 3.5 hours, the last layer of drywall began breaking off, exposing the wood-frame cavity.
