## An argument for fully engineered post-frame buildings

By David Bohnhoff, PE, PhD, University of Wisconsin

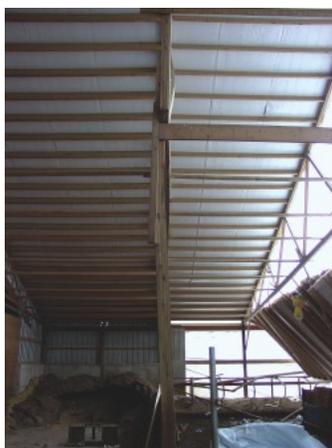
Figure 1: Buckling of a nail-laminated post due to improper design. Also visible is the buckling of the compression web chords due to improper bracing.

A prime example of the problems this causes was on full display in Myren's freestall barn and the other five failed buildings I visited the same day. Many of these buildings had seriously under-designed interior columns. As constructed, most of these columns would have an allowable axial design load of zero (0) which explains the classic buckling observed (figure 1). Other major deficiencies included no column sideways control at connections between interior columns and trusses, no accounting for additional loads induced by drifting snow and improper truss web bracing. With respect to the latter, all buildings I inspected with roof trusses utilized continuous lateral restraint (CLR) systems to brace longer compressive web members. Unfortunately, every CLR system was improperly installed, as none of them included diagonal bracing to prevent CLR shifting. This resulted in web buckling (figure 2) and subsequent truss failure.

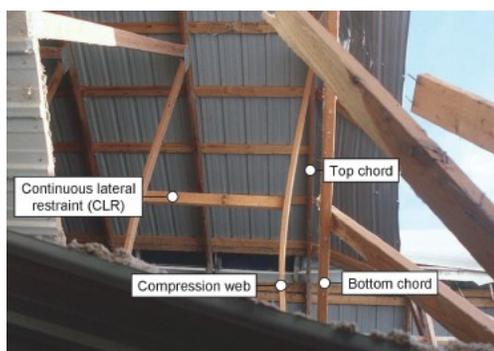
Figure 2: Shifting of the CLR enables the compression web to buckle out of the plane of the truss. All trusses to the right of the one labeled here failed in a progressive manner.

With a CLR system, when one truss fails, the lateral restraint attached to that truss pulls on the similarly buckled webs of the two adjacent trusses (i.e., the trusses located on each side of the failed truss). The

truss on one side of the failed truss is helped by this action and does not fail (as its bowed compressive web is somewhat straightened out).

Conversely, the truss on the other side of the failed truss becomes more compromised as its buckled web is pulled further out of alignment. This almost always snaps the web of that truss, resulting in its collapse. The collapse of this second truss brings down the next truss in a similar fashion. In a domino-like fashion, trusses continue to fail until there are no more trusses to pull down. This entire failure process explains why this mode of failure is characterized by a partial roof collapse that ends at a wall.
